08 November 1993 (Revised)

Subject: Geohydrologic Characterization
Mister M Landfill
Lewistown, Montana

SITE PLAN — Test Pit and Boring Locations; Surficial Geology
PROJECT NO. 579-03 NOVEMBER 1993

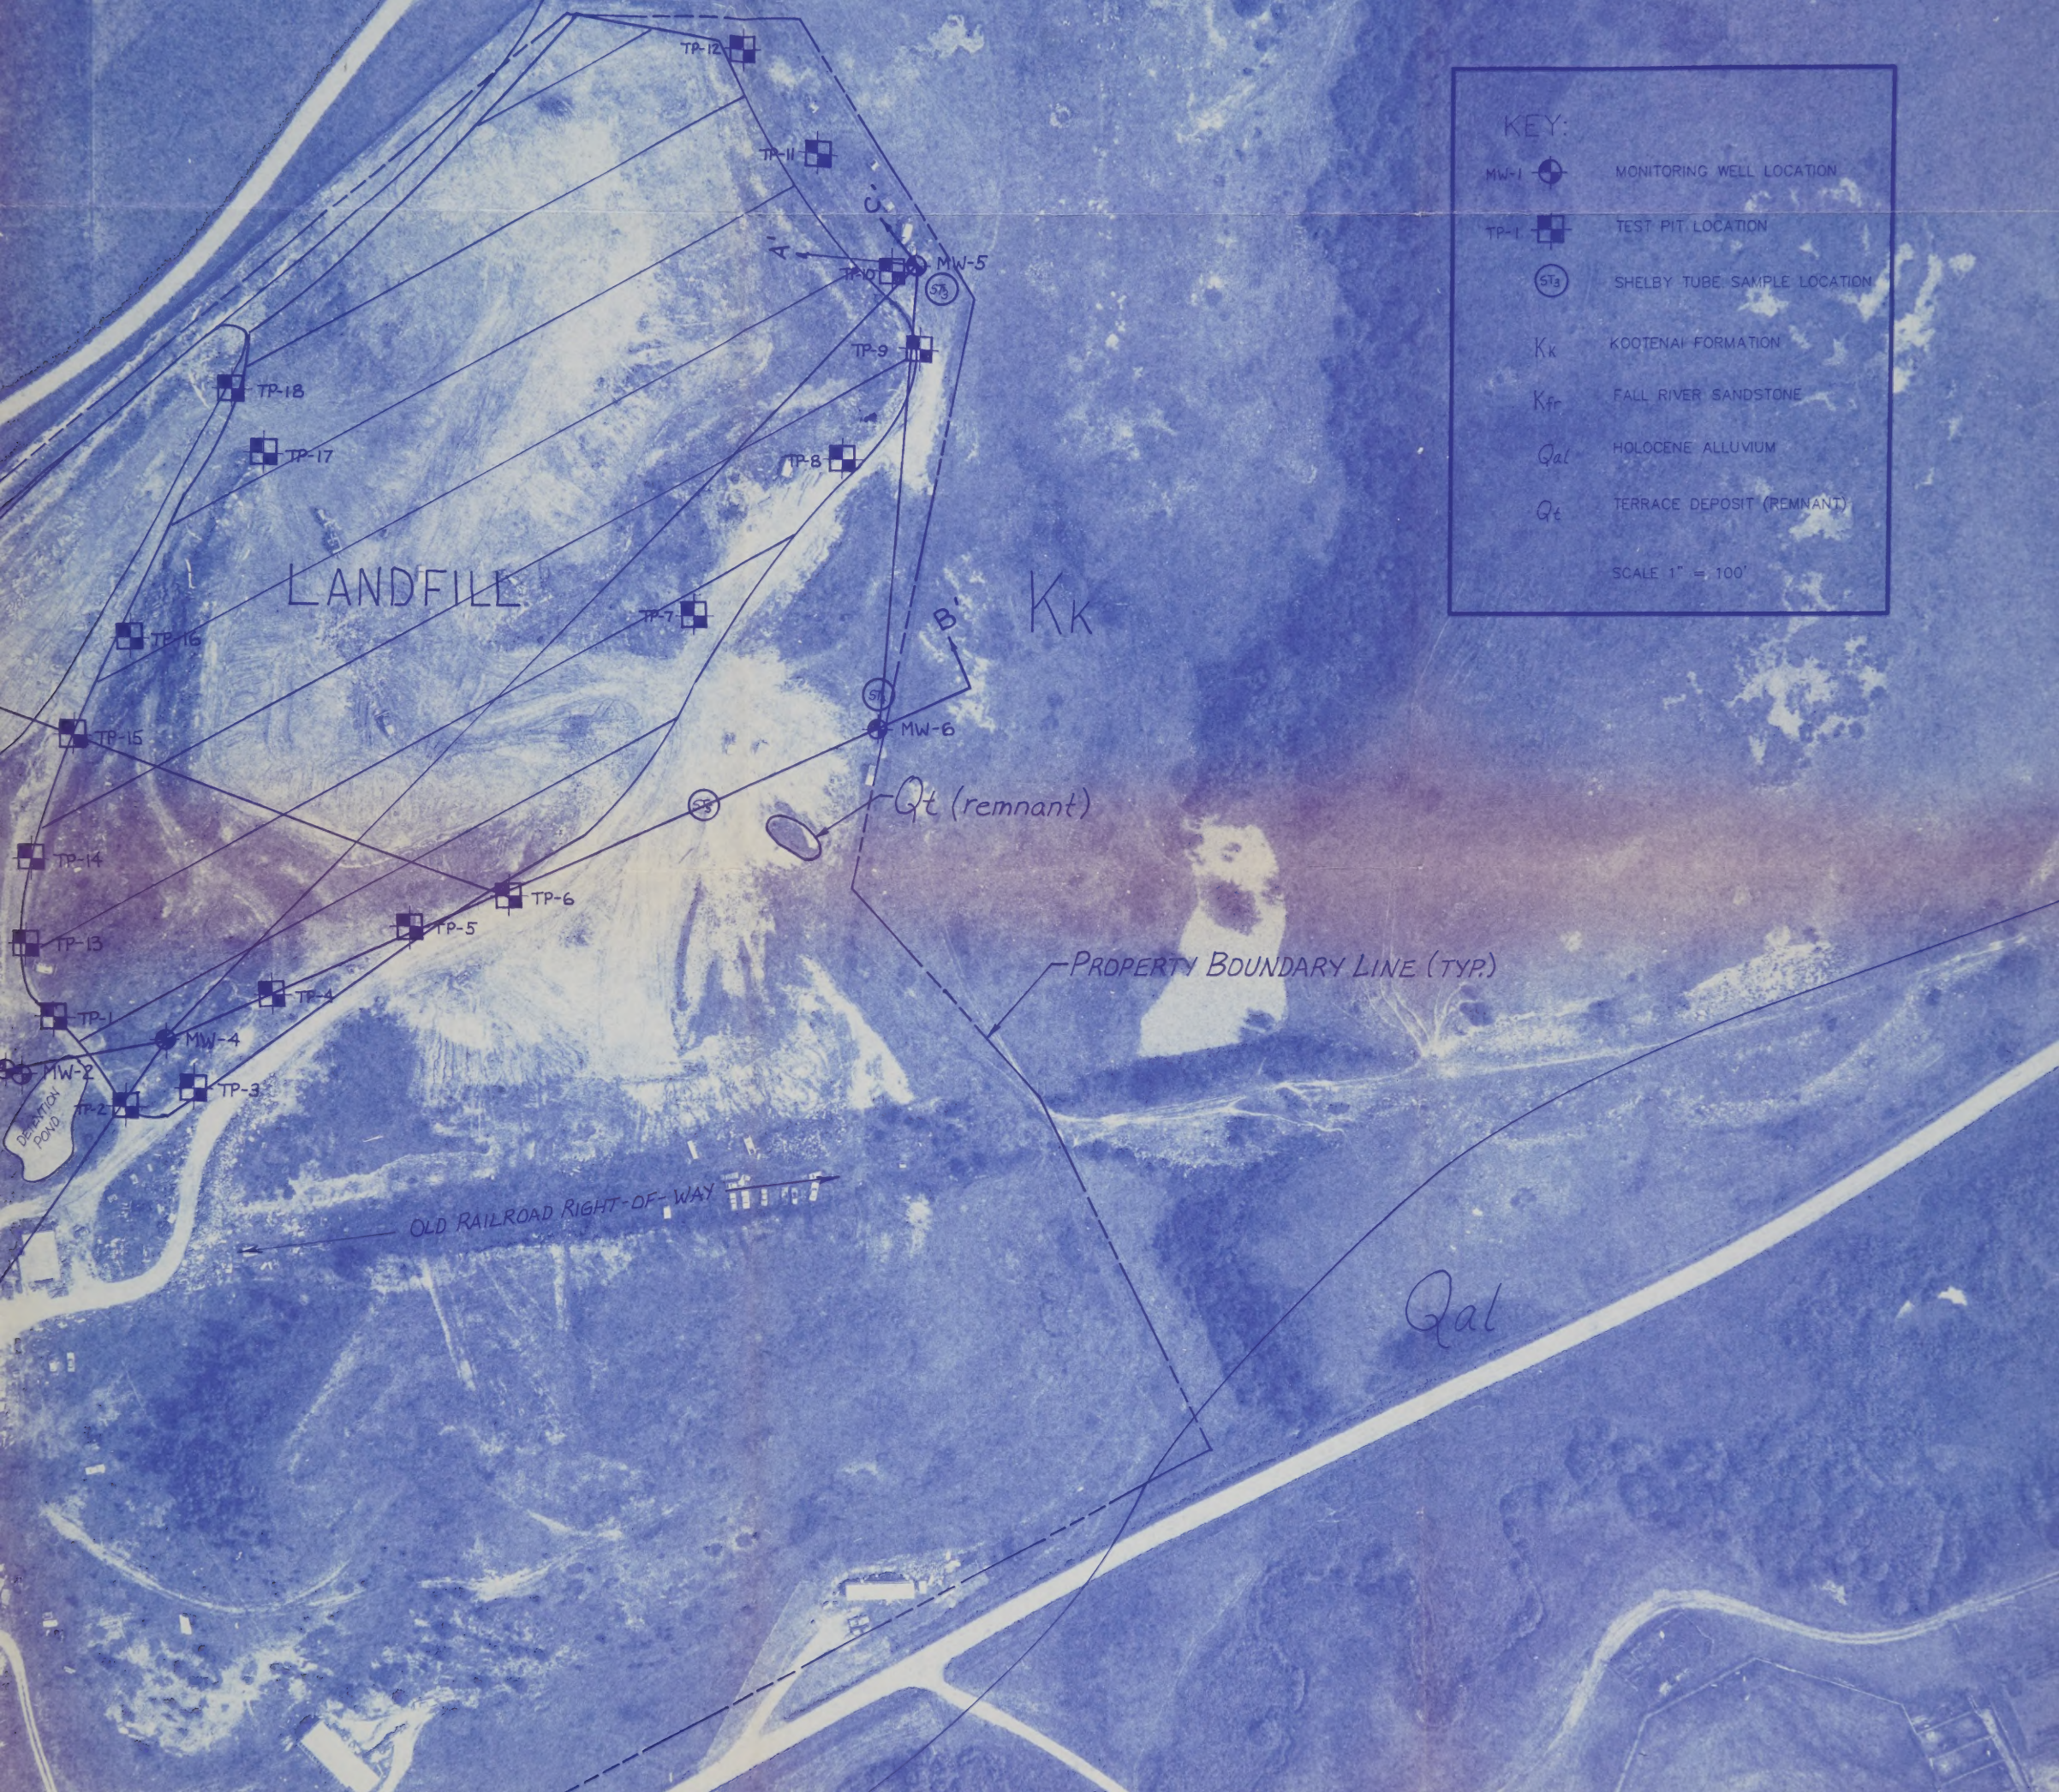
FIGURE 2

Shelby tube samples of the surface and near soils were obtained from various locations within the confines of the site; locations are shown on Figure 2. The samples were collected by hydraulically pressing a 3 inch Shelby tube into the soil after removal of the topsoil (if present). The tubes were sealed with plastic caps and dipped in wax to prevent moisture loss and help stabilize the sample for transport.

Subchapter 7 requires a minimum number of test pits and other subsurface exploration points based on the areal extent of the landfill. As presented in the work plan, eighteen test pits were excavated at the locations shown on Figure 2. The excavations were made with a Drott backhoe mounted on a 5 ton 4x4 truck and were carried to refusal on bedrock in all cases. Our geotechnical engineer logged the pits for soil or rock type, lithology, moisture content, and evidence of ground water, and developed field logs in accordance with USCS procedures.

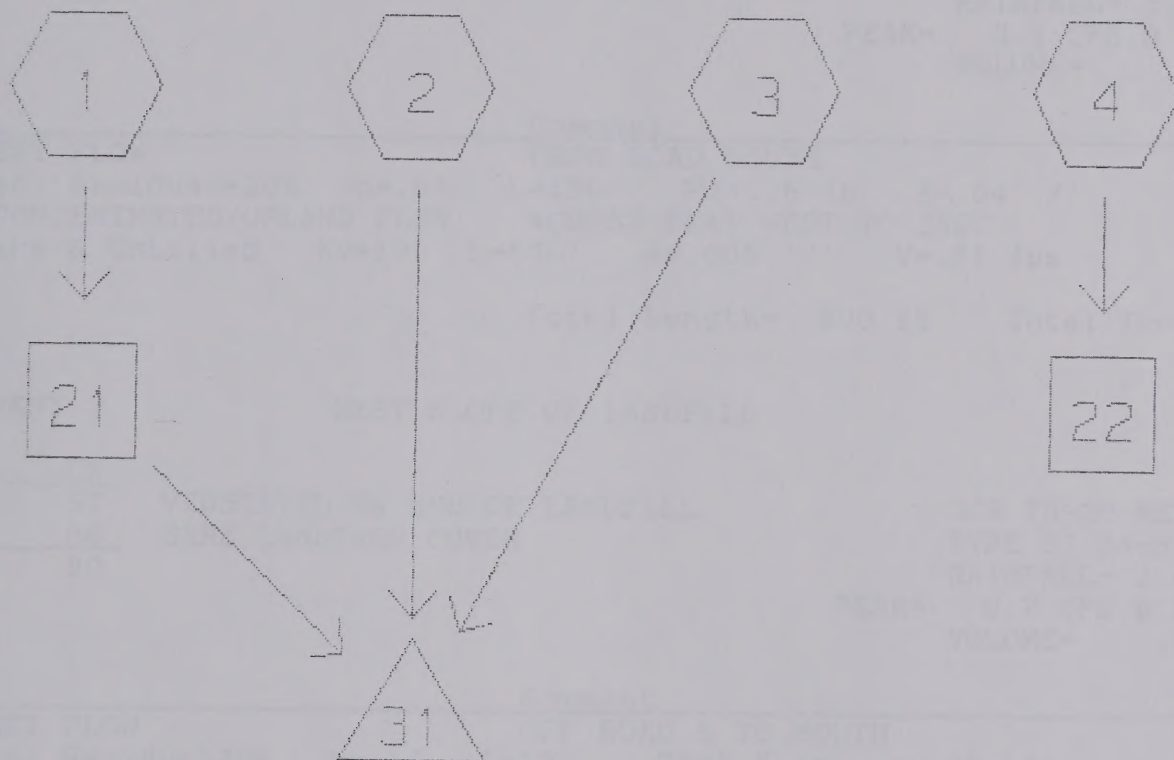
Erosion in ditches and swales and at the pond outlet will continue to occur even after the landfill is capped and vegetated unless these areas are stabilized. From the summary sheets and tables on pages 12 through 17 of the Hydrocad Report and pages 21 through 25 attached to the Hydrocad Report, velocities in the ditches and swales exceed 3 feet per second in the 10-year and 25-year storms. Possibly some of these can be stabilized with vegetation, but it is likely riprap or a synthetic erosion control mesh will be needed in the ravine along the southwest side of the landfill, along the access road, and at the pond outlet.
